Fan failure analysis and repair

by Russell E. Baetke ©
Seattle, Washington

MODEL A FAN
 1928 - 1931
 Drawing constructed
 from original parts
 by Russell E. Baetke

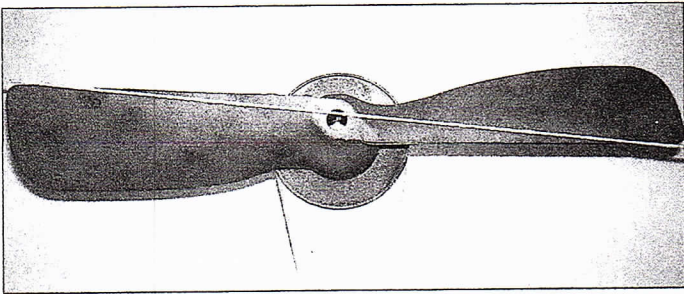
1. Fan before straightening. Shows blade offset from center at shaft hole.

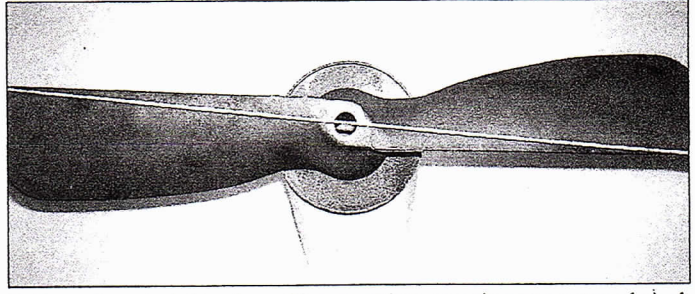
2. Fan after straightening. Shows string crossing at center of shaft hole. Ready for preliminary welding.

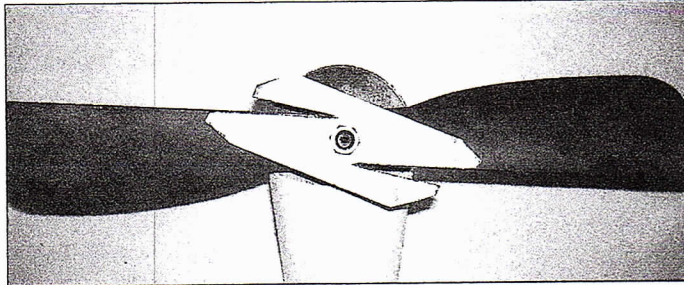
3. Overlay bolted in place before preliminary forming.

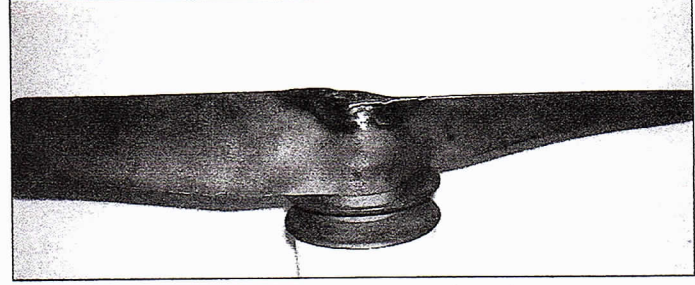
4. First welding of all unwelded seams and cracks.

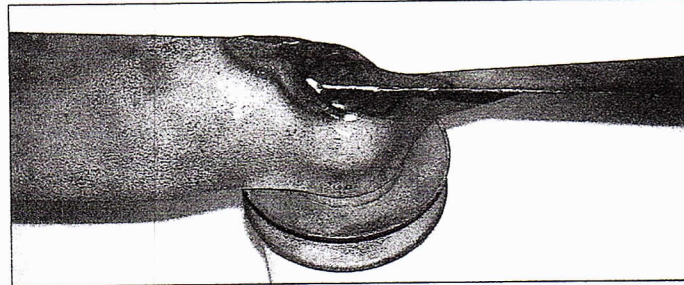
5. Welding ground flat to surfaces in preparation for final overlay forming.

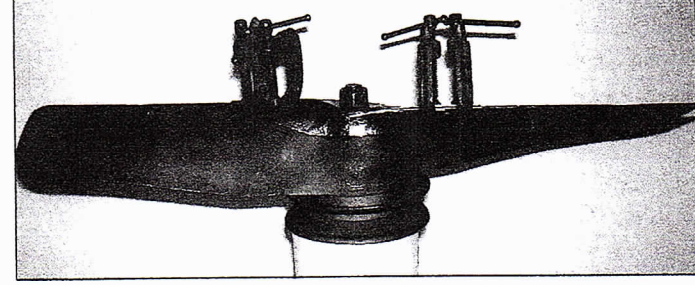
6. Overlay final form. Clamped at ends and ready for welding.

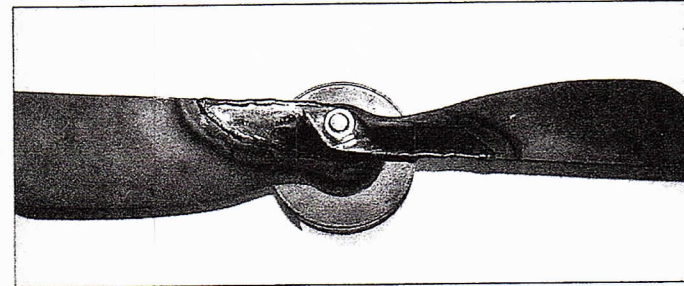
7. Welded overlay. All edges welded to fan.

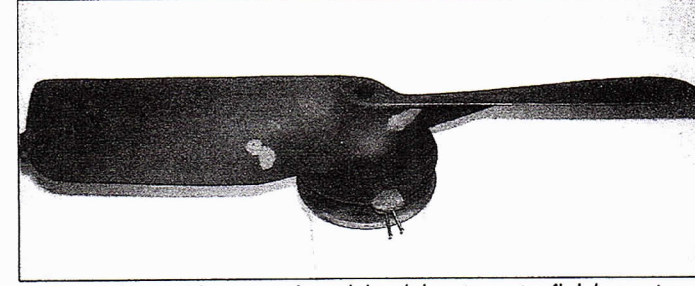
8. Fan with welds ground and lead in steps to finish contour. Primed and balance weights.

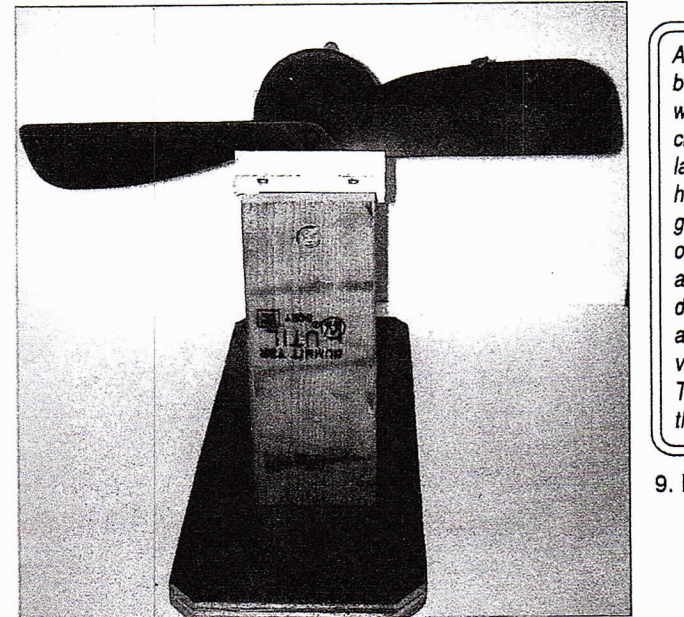
9. Balance weights reduced and ready for final finish.

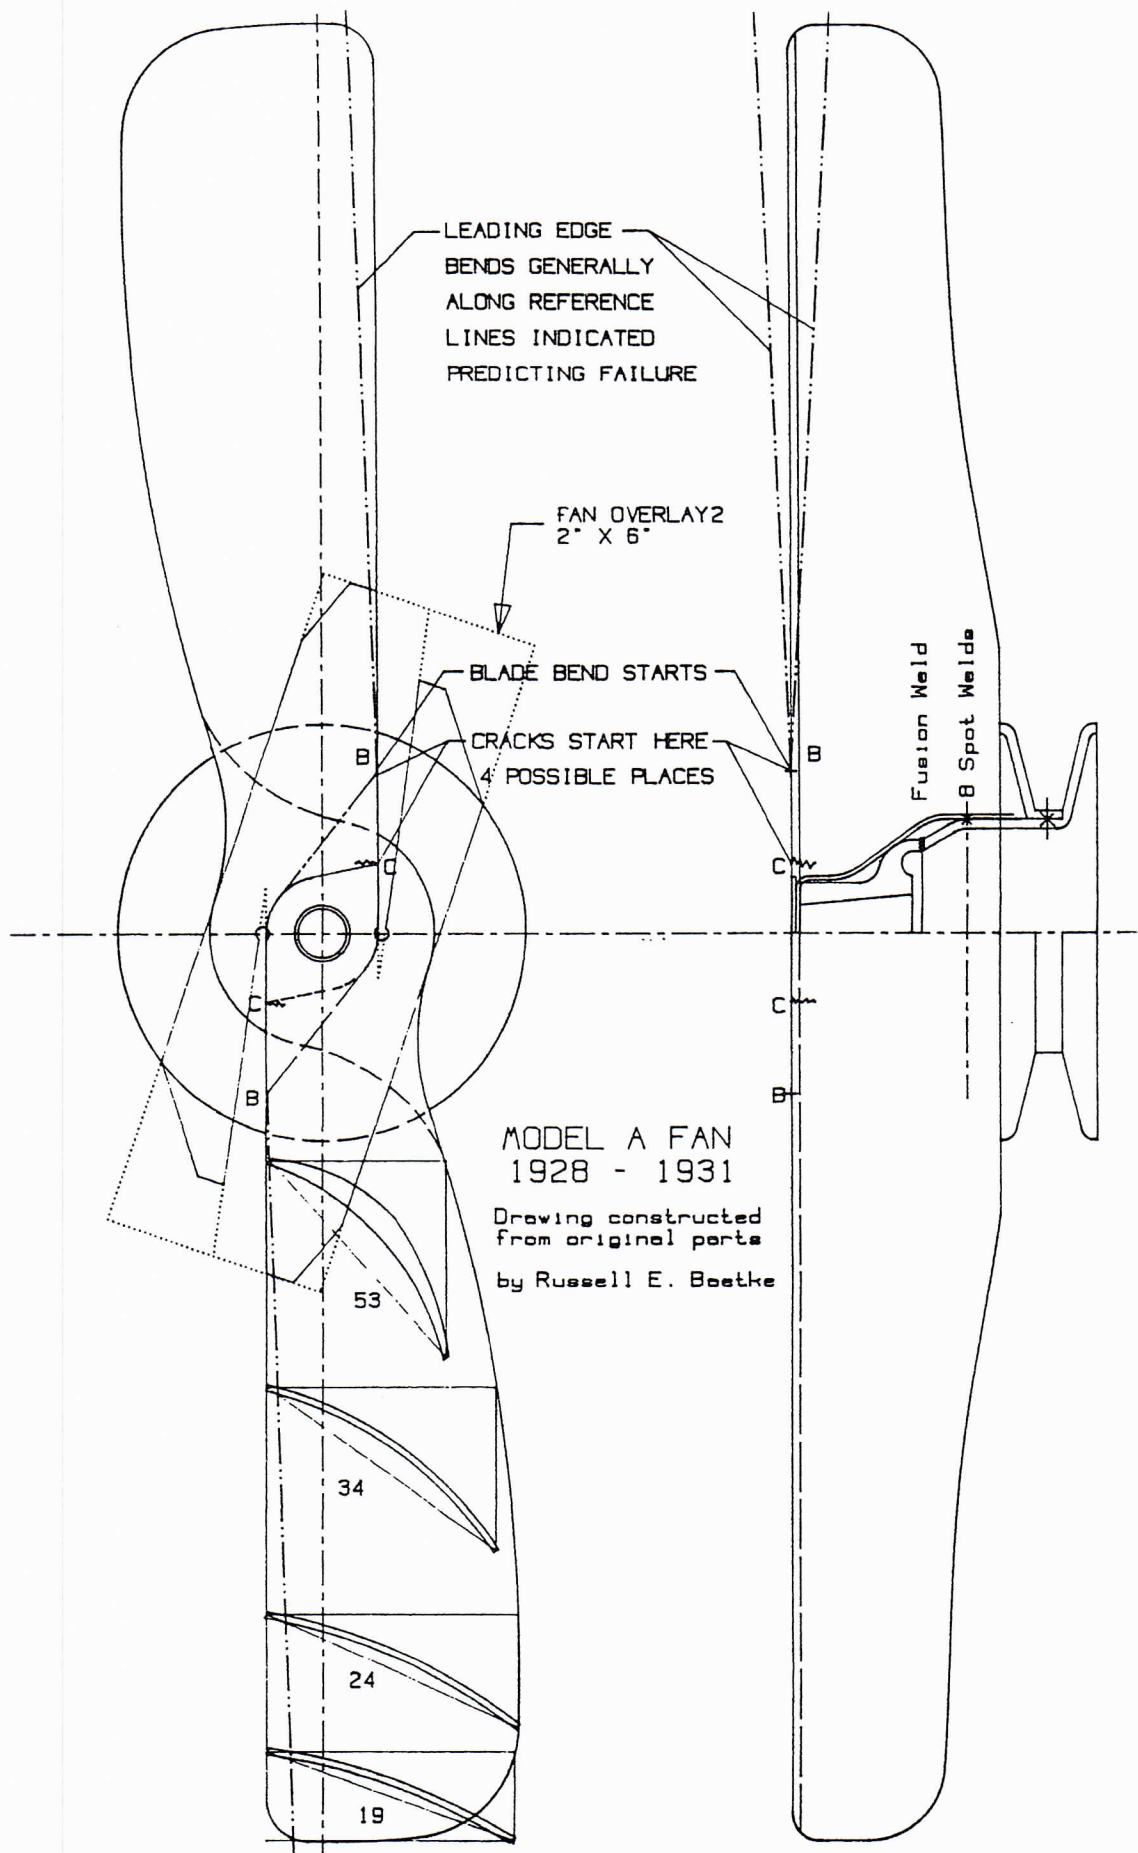
A very small crack starts on the side about 5/8" out from the shaft center and progresses on to the forward flat face where the shaft nut is installed. The cracking areas are identified on the drawing. This is a spot where the fan blade leading edge forms into the hub. From here the crack expands across the front face at the same location. Sometimes the progressing crack jumps about 5/8" further outboard to the location where the blade leading edge seam welding terminates. In this area the blades may also have a visible bend backward (sweep back) due to fatigue.

LEADING EDGE
 BENDS GENERALLY
 ALONG REFERENCE
 LINES INDICATED
 PREDICTING FAILURE

BLADE BEND STARTS
 CRACKS START HERE
 4 POSSIBLE PLACES
