Glass & Regulator Remedies

Sharpen up Your Old Model A Restoration or That New Job With Some Corrective Adjustments.

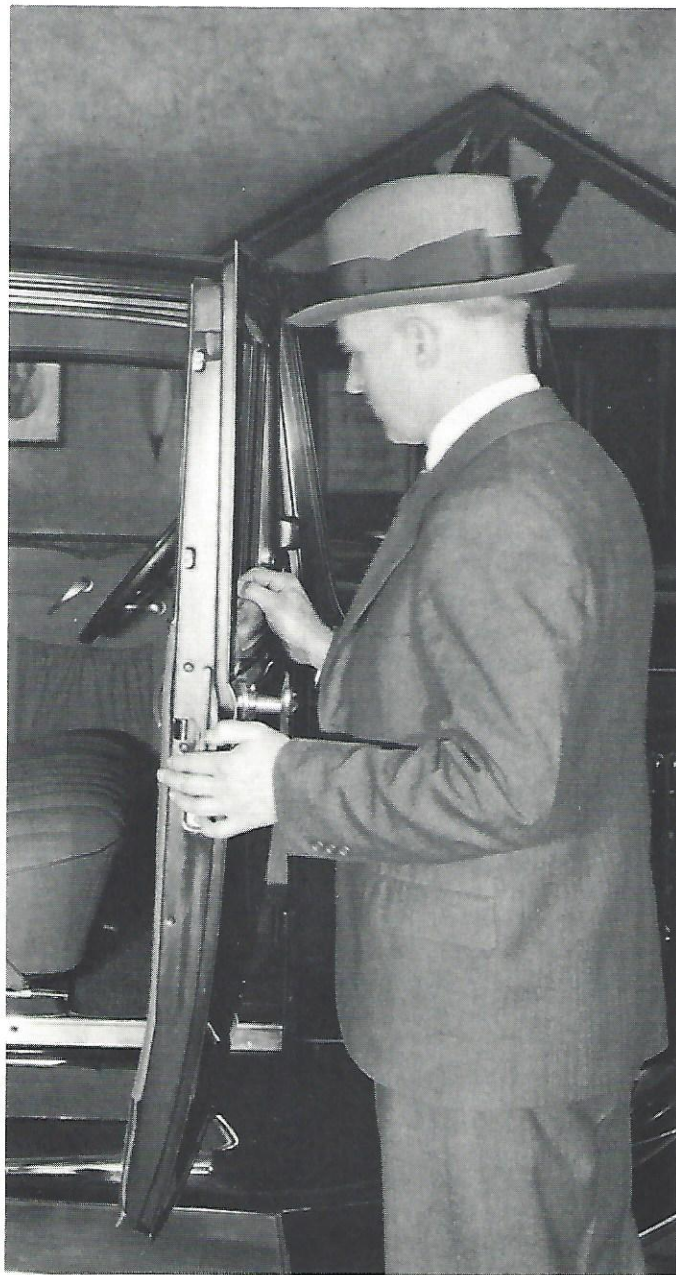
Fig. 1

A typical design of window regulator used by the closed-body Model A Ford is shown in Fig. 1. The inside crank handle operates a set of gears to raise or lower the arm, which is attached to the steel glass channel holding the glass by a roller that travels in a slot in the channel. The roller travels horizontally as it assumes the different positions given it by the lifting arm when the glass is being raised or lowered.

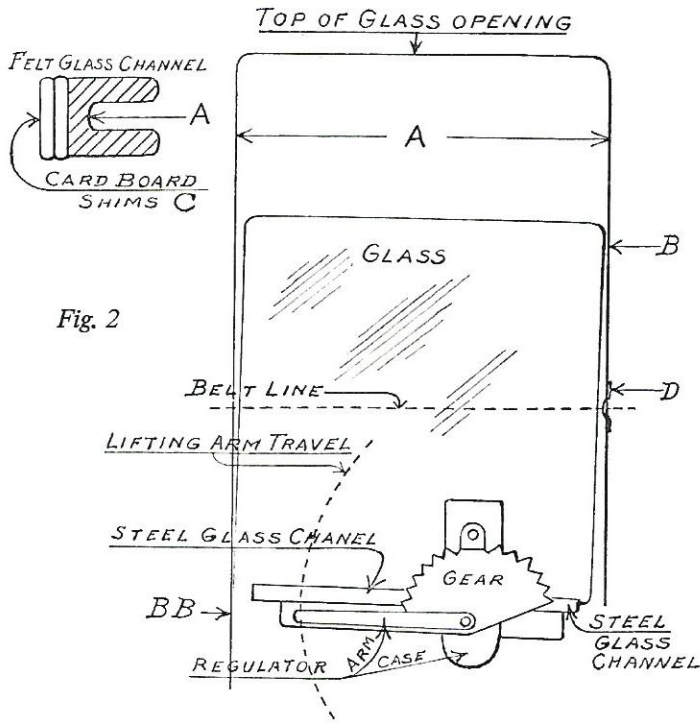
Fig. 2

Accordingly the lifting action at the bottom of the glass panel is always more or less beyond center. It is farthest from the center when the arm is parallel with the steel glass channel, as shown in Fig. 2, and therefore exerts a side pressure when in motion up or down. For example, as the glass is being raised the top corner of the glass at B is being crowded hard against the felt glass channel, and in cases where the glass is too narrow for the space between the glass channels, shown in Fig. 2, the glass is thrown out of alignment and will stick or otherwise fail to function properly, and eventually will tear the felt glass channel. The glass panel should fit snugly between the channels, allowing a small amount of clearance only for the channel expansion that occurs in damp weather.

Another method of correction, particularly when the glass is found to be $\frac{3}{16}$ inch or more too narrow for the opening A, is to take up the opening with a sash spring, shown at D in Figs. 2 and 3. Sash springs $3\frac{1}{2}$ inches long and $\frac{3}{8}$ inch wide are sometimes obtainable as obsolete stock or can be

Lower the glass all the way down and insert the sash spring between the glass and felt channel so that the top of the glass is centered with the arch of the spring at the belt line. Then attach the spring through the felt channel to the steel post with a flat-top rivet or screw it to a wood post.

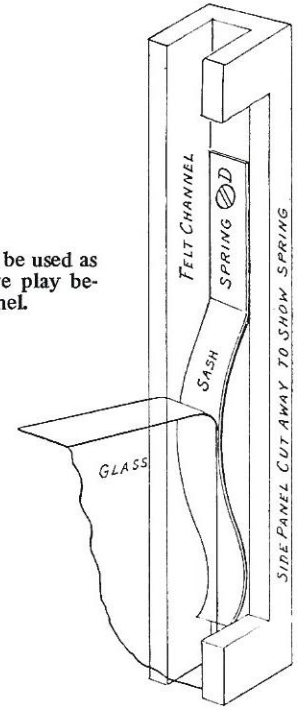
Fig. 3 (right) Sash springs can be used as a means to eliminate excessive play between window glass and channel.

made using the illustration (Fig. 3) as a guide. Although the spring is slightly wider than the channel opening it can be set inside of the channel.

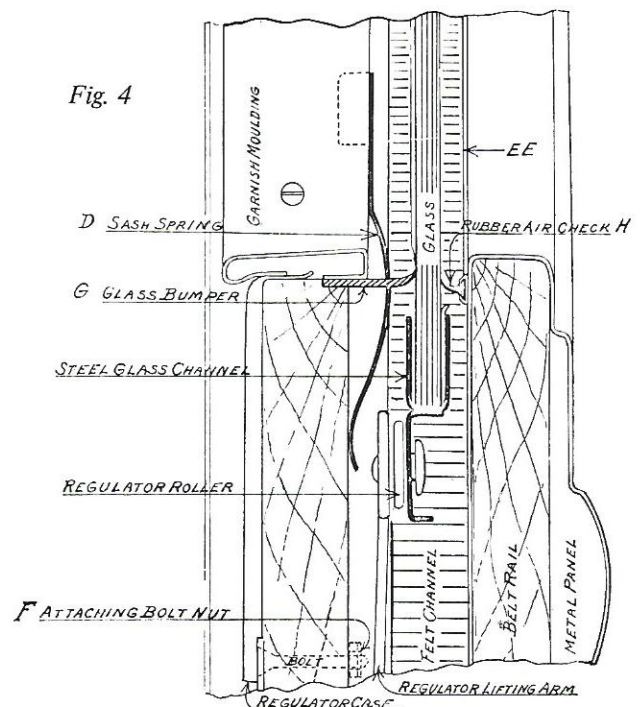
From other causes, too, the roller may fail to function. Occasionally trouble also is found when the attaching screws or bolts protrude beyond the inside of the belt lining bar so far as to strike and hold the regulator lifting arm as it passes. Note F on Fig. 4. Correct this by cutting off the ends of the bolts. Slightly bending the regulator arm so that roller will bear against the glass channel will correct a rattle that may develop at this point. Care should be taken, however, as severe pressure at this connection will tend to cause the glass to break when the door is slammed shut.

Fig. 4 (below) A typical wood frame automobile door section.

To check the whip of the top of the glass when down in the door, Ford body manufacturers placed a rubber bumper about 1½ inches long (**G** in Fig. 4) to the top center of the belt bar under the Model A garnish moulding. The bearing of the bumper on the inside of the glass and the rubber air check **H** in Fig. 4, running the entire length of the belt rail, is supposed to eliminate the whip of the glass.

If the opening between the glass and channel is too small to insert a spring in the channel as in Figs. 2 and 3, the same type of sash spring can be set between the garnish moulding and the felt glass channel to take up play in the glass, as shown by D in Fig. 4. One spring on one side is generally sufficient to check the rattle, but if it is not, a spring can also be set in on the other side. Should the spring cause the glass to strike and rattle against the belt rail, place the spring on the opposite side of the felt glass channel at the point EE. Note that the spring is set well down below the top of the belt line and in this case should not affect appearance.

Should you fail to find some form of bumper such as **G**, or bumper **G** fails to bear against the inside of the glass, remove the garnish moulding and tack a piece of flat rubber along the entire length of the top edge of the belt bar with the outside edge of the rubber strip bearing on the glass. Windshield **T** rubber with the flange cut off will serve as a replacement rubber strip if a stock item cannot be located.

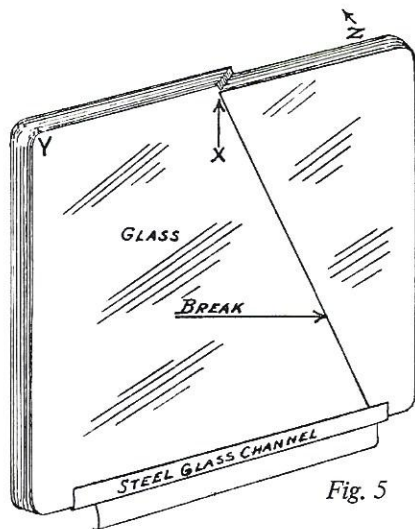
after the break should help you determine the cause. Note glass break X in Fig. 5, which illustrates the appearance of a glass break when the glass runs in the posts are out of line. Channel point Y should be moved in or point Z moved out to make X parallel.

Fig. 5 (above) A careful observation of the location and direction of a break can help determine the cause.

Should the break occur when the glass is up, correction can be made by shifting the garnish mouldings to relieve the strain. If the break occurs while the glass is down the upholstery should be removed and the glass run rabbet cut wider. Should the run become too wide and allow the glass to rattle, tighten with a sash spring.

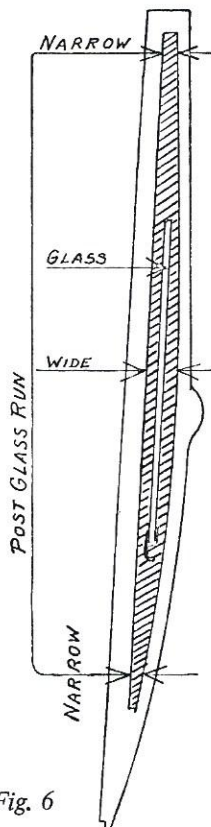
garnish mouldings are too far in against the felt channels they may cause breakage when the glass is part way down. As the body is narrower at the bottom than at the belt and top, it is necessary for the post glass runs to be wider at the belt than at the ends to allow the glass clearance to complete the curve of the body, as shown in Fig. 6. For this reason we suggest the sash spring **D** in Figs. 2, 3 and 4 to take up side play in the glass at the belt, rather than the easier stunt of moving in the bottoms of the side garnish mouldings.

Fig. 6 (right) Post glass runs must be wider at the belt to accommodate the flat glass travelling the curve of the door.
