THE BANGER A'S VOICE OF THE NAPER A'S

THE 4-BANGER VOLUME 7, ISSUE 4 🛨 WINTER, 2021

NICK'S LEFT REAR FENDER REBUILD

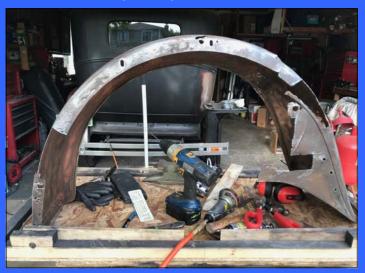
Fender after the rotted partitions were removed and a few tools of the trade.

decided to start with the left (driver's side) rear fender and wheel well panel as this area was in the worst condition owing to significant rust-out and damage from an accident. After removing the rot, I filled the gaps by cutting, shaping, and welding in new segments of 22 gauge steel, making sure to reproduce the numerous compound curves of each part... a tricky challenge for a novice! I turned to YouTube for

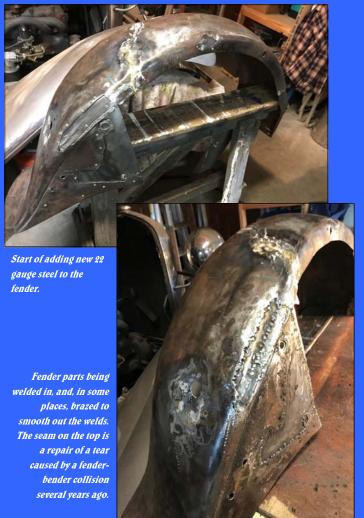
Well panel support beam being replaced using 16 gauge steel with three reinforcements struts.

Outer part of the floor pan at the junction being replaced. This required blending it into the new side panels with the new beam acting as the common connection point.

Well panel with rust-out removed.

Panel rebuilding using individual 22 gage pieces to match the original stamped panel. Note that the nut plate the fender attached to needed new nuts welded in and then needed blending into the rear panel.

Before I could assemble my replacement panel segments, I needed to rebuild the understructure of the wheel well. This proved to be one of the most crucial and difficult elements of the job. A structural beam which is supposed to run along the undersurface of the well to give shape and strength to a seam where multiple panels join was virtually gone. I constructed a new one, measuring 2 inches wide by 32 inches long, out of 16 gauge steel bar. As I added my replacement panel pieces to the well, I successively anchored them to the new support beam.

As I worked behind the panel, I discovered that I also needed to rebuild areas of the outer floor pan and interior side panel of the cabin. Eventually I layered all of these parts together in their proper order and welded them in place to reform the complete wheel well panel.
