Fan failure analysis and repair

by Russell E. Baetke ©
Seattle, Washington

MODEL A FAN
 1928 - 1931
 Drawing constructed
 from original parts
 by Russell E. Baetke

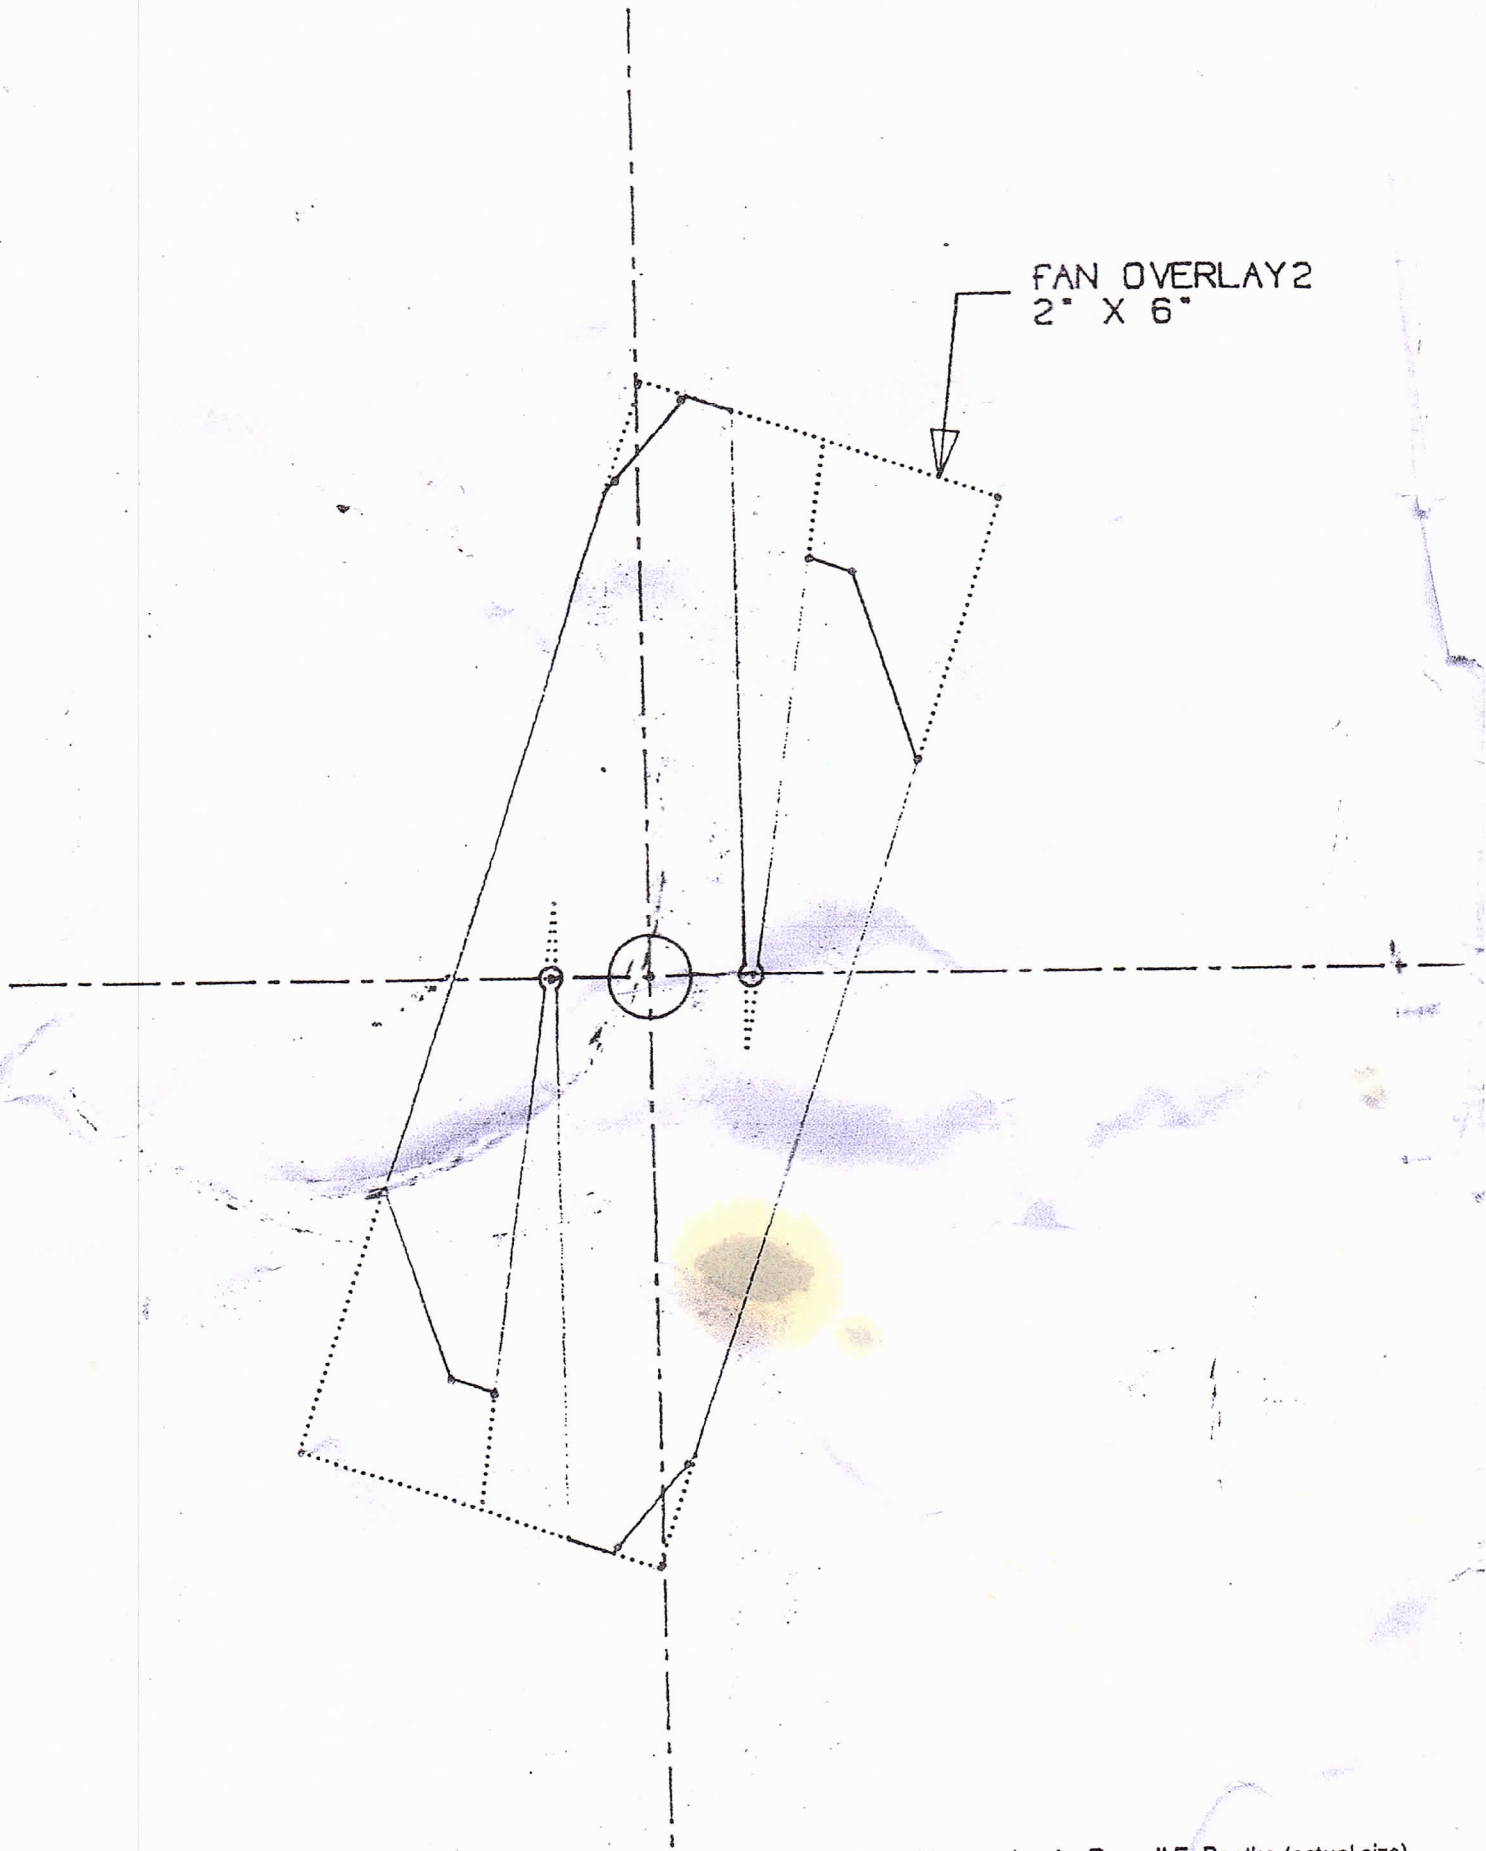
FAN OVERLAY2
2" X 6"

Drawing of fan overlay by Russell E. Baetke (actual size).

The repair I developed is a sheet metal overlay made in one piece which when formed will fit over the front and rear surfaces of the crack effected area to make the two fan sheet metal pieces work as one. The part forms quite well with relatively little stretching. When the part is shaped, recheck the blade alignment with the string. It is then wire feed welded or surface brazed onto the fan. All edges are ground to a smooth edge and lead filled to taper it into the contours. This avoids stress concentration and makes the overly near invisible when installed. The template of the overlay is drawn to scale shape. I did start with a simpler shape, and that simpler shape is the one that has been running in my car. This shape is more suitable since tears propagate onto both front and rear surfaces which are the places of origin for the failure. As to the complexity of doing this, it is necessary to operate a gas torch if you braze or job out the TIG welding as required. Other than that, normal body tools are all that are needed. The overlay bends down to the fan contour with minimum stretching.
